Manhole Inspection Summary

Manhole # S69C1_012MH

Insp Date: **2/12/08 9:54 AM**

Location Address: **Behind 6501 Detroit Ave. in alley** Cross Street: **Chesapeake Ave.**

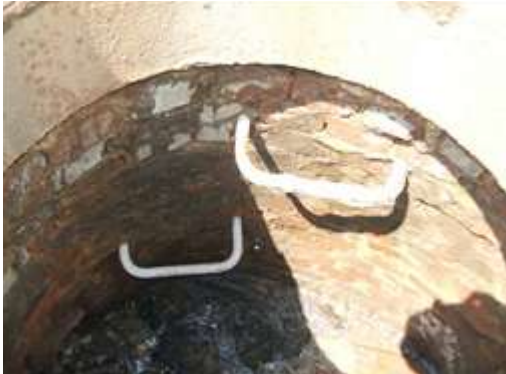
Defect 1

Chimney / Frame Adjustment ☒ Exists Material: **Brick** ☐ Parged Height: **4** (in.)
Condition: ☒ Sound ☐ Cracked ☐ Root Intrusion ☐ Loose Brick ☐ Deteriorated
Infiltration: ☐ None ☒ **Joint** ☐ Cracks ☒ **Mortar** ☐ Roots ☐ Wall

infiltration

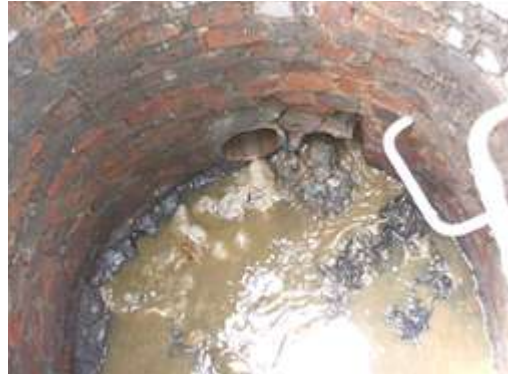
Defect 2

Comments **6 INCH PIPES. 7 O'CLOCK PIPE WAS CLOGGED AND AFTER DISLODGING THE CLOG, SEWAGE POURED OUT, FILLING MANHOLE 6INCHES.**

sewage pouring outta blocked pipe

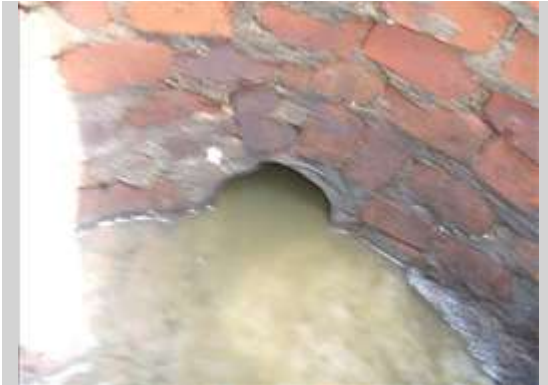
12 O'Clock Outflow

6 in. Circular Gravity Sewer
Pipe Out @ 12 O'Clock

Deposits: ☒ None ☐ **Mud** ☐ Sludge ☐ **Debris** ☐ Grease

Infiltration: **None** Pipe Seal Cond: **Sound**

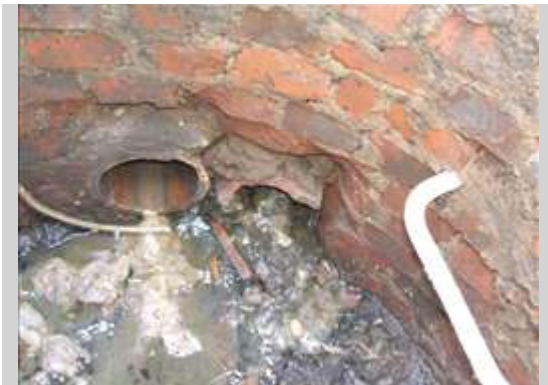
6 O'Clock Inflow

6 in. Circular Gravity Sewer
Pipe In @ 6 O'Clock

Deposits: ☒ None ☐ **Mud** ☐ Sludge ☐ **Debris** ☐ Grease

Infiltration: **None** Pipe Seal Cond: **Sound**

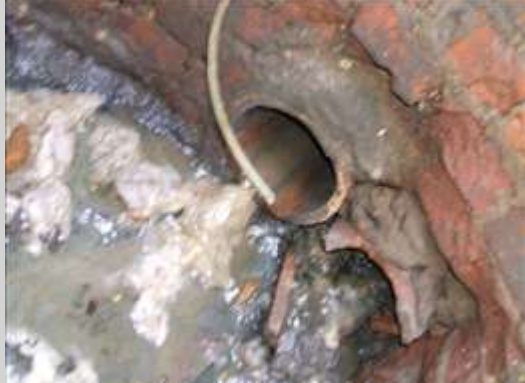
7 O'Clock Inflow

6 in. Circular Gravity Sewer
Pipe In @ 7 O'Clock

Deposits: ☐ None ☒ **Mud** ☐ Sludge ☒ **Debris** ☐ Grease

Silt Depth: **4** (in.) Deposits Extent: **Heavy**

Pipe Seal Cond: **Broken**
